Flight Service Evaluation of Kevlar-49 Epoxy Composite Panels in Wide-bodied Commercial Transport Aircraft

Sixth Annual Flight Service Report

R. H. Stone

LOCKHEED-CALIFORNIA COMPANY
BURBANK, CALIFORNIA

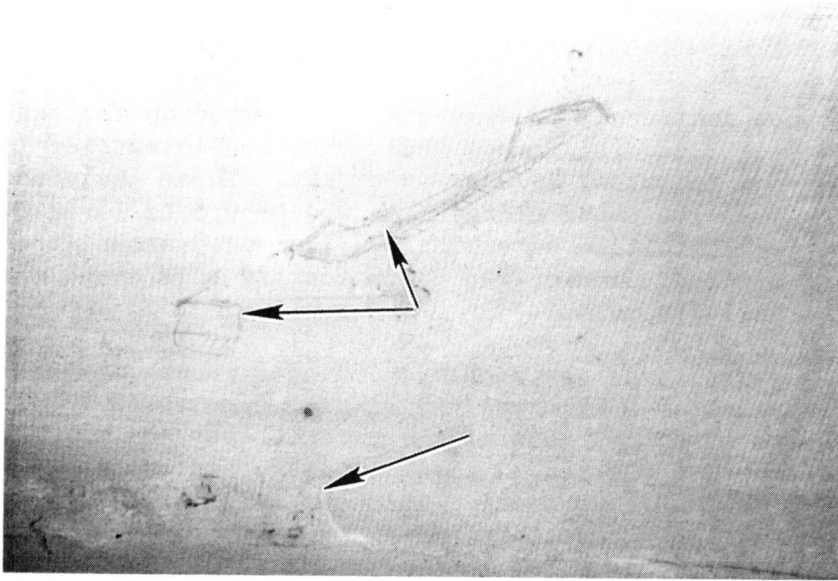
3. An area 26.7 cm (10½ in.) by 3.2 cm (1¼ in.) slightly below the two upper delaminations was first observed in 1977 to have an overlay, presumably a repair patch, which had been sanded. (Figure 4). This area was unchanged in appearance. There was no associated delamination.
4. A gouged area with loose fibers was noted on the lower forward area of the inner surface. (Figure 5). This condition had not been observed previously.
5. Slight fraying was observed on all fastener holes on the top, forward, and aft edges. A greater degree of fraying was observed on the holes on the lower edge. (Figure 6). For comparison, a fastener hole from a similar fiberglass fairing is shown in Figure 7.
6. Several holes on the lower edge were elongated. No holes on the other edges were elongated. Fastener mark-off was observed on the inner surface around all holes on the lower edge. (Figure 8).

Figure 4. - Air Canada right-hand wing-body fairing showing outlined areas of delamination and overlay patch on inner surface.

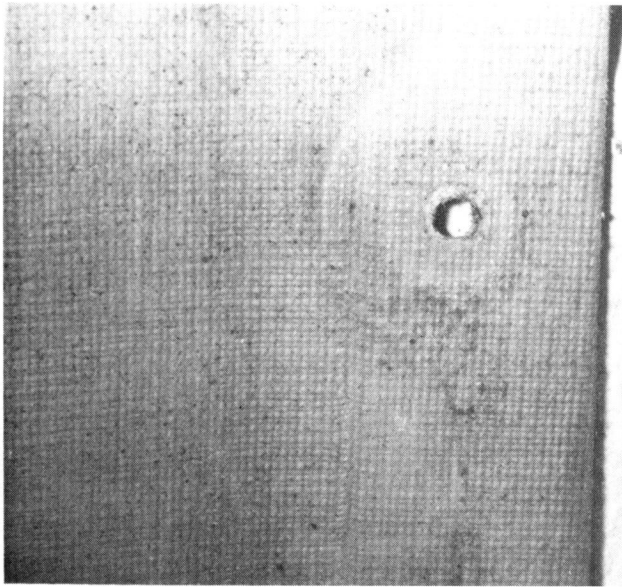
Figure 6. - Air Canada right-hand wing-body fairing - typical fastener hole.

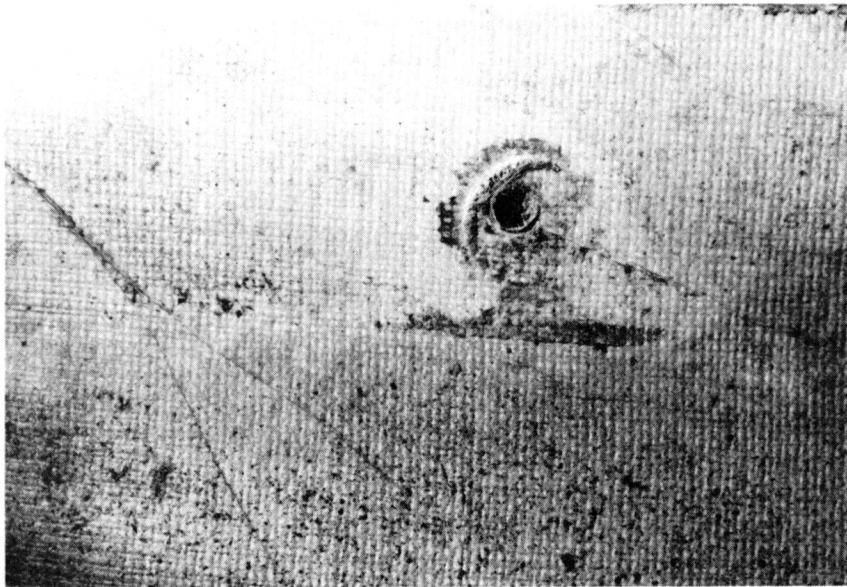
Figure 8. - Air Canada right-hand wing-body fairing - fastener hole on lower edge with mark-off.

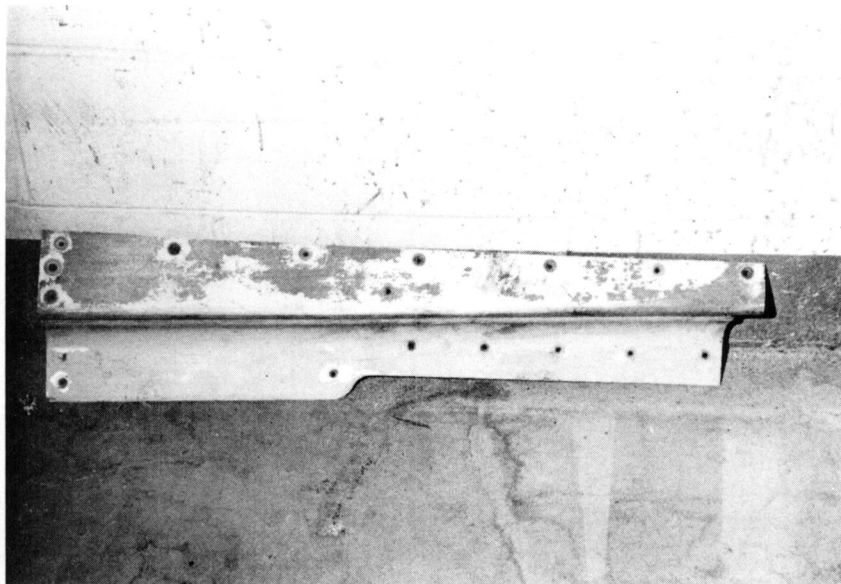
1. No surface damage or defects were noted on either surface although there was considerable paint loss with exposed Kevlar-49. (Figure 9). The location of the exposed Kevlar-49 is such that very little ultraviolet exposure can occur.
2. Fraying was noted on most of the fastener holes, (Figure 10), with four holes more frayed than the others. About half the holes had a significant degree of elongation, with seven holes elongated to 0.55 cm (7/32 in.) maximum dimension from the original 0.5 cm (3/16 in.) diameter, and two holes elongated to 0.6 cm (1/4 in.). There was no correlation between the frayed and elongated holes.

Figure 9. - Air Canada right-hand underwing fillet - exterior surface showing paint loss and exposed Kevlar-49.

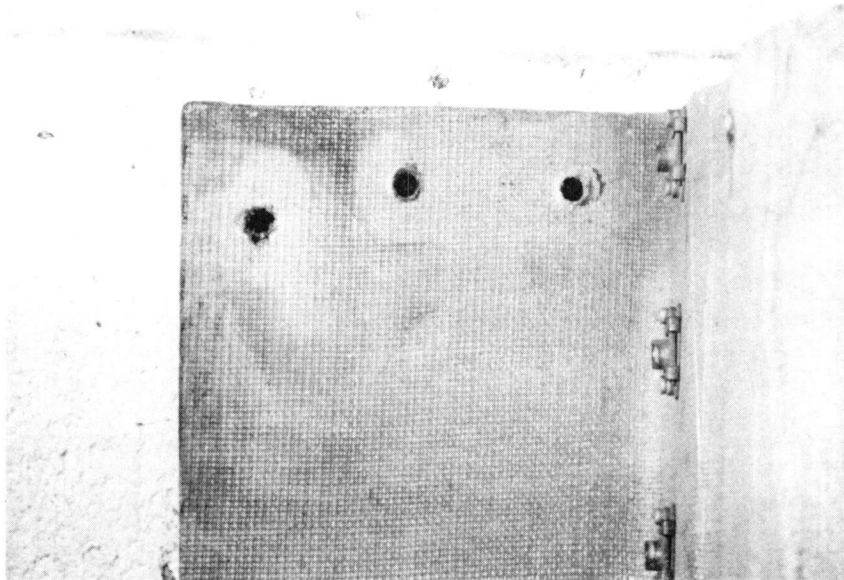
Figure 10. - Air Canada right-hand underwing fillet - fastener holes with frayed condition.

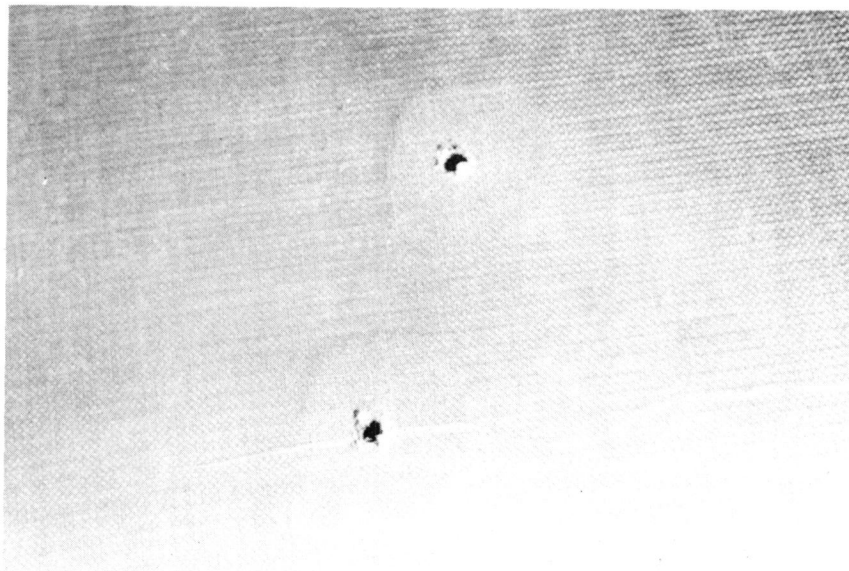
1. No damage, delamination, or disbond was observed on either surface.
2. All of the fastener holes were heavily frayed. (Figure 11). A small number of holes were elongated: four holes to a maximum 0.55 cm (7/32 in.) dimension from the original 0.5 cm (3/16 in.) diameter, and four holes to a maximum 0.6 cm (1/4 in.) dimension.

Figure 11. - Air Canada left-hand aft engine fairing - fastener holes in core area showing frayed condition.

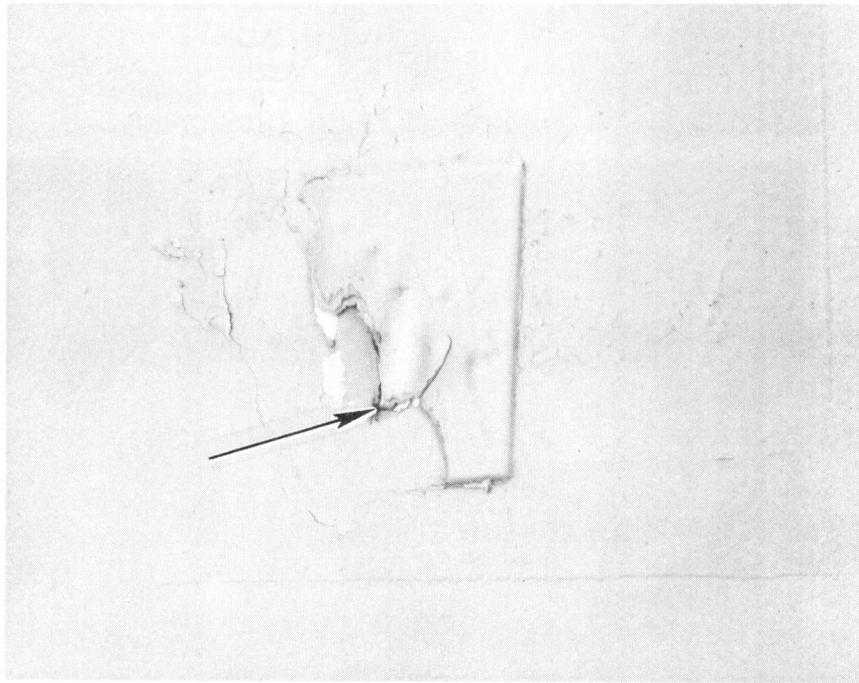
2. A speed tape patch first observed in 1975 had more area torn off partially exposing the original crack to a length of 1.6 cm (5/8 in.). (Figure 12). There was still no associated delamination.

Figure 12. - Eastern left-hand wing-body fairing - speed tape patch with exposed crack.

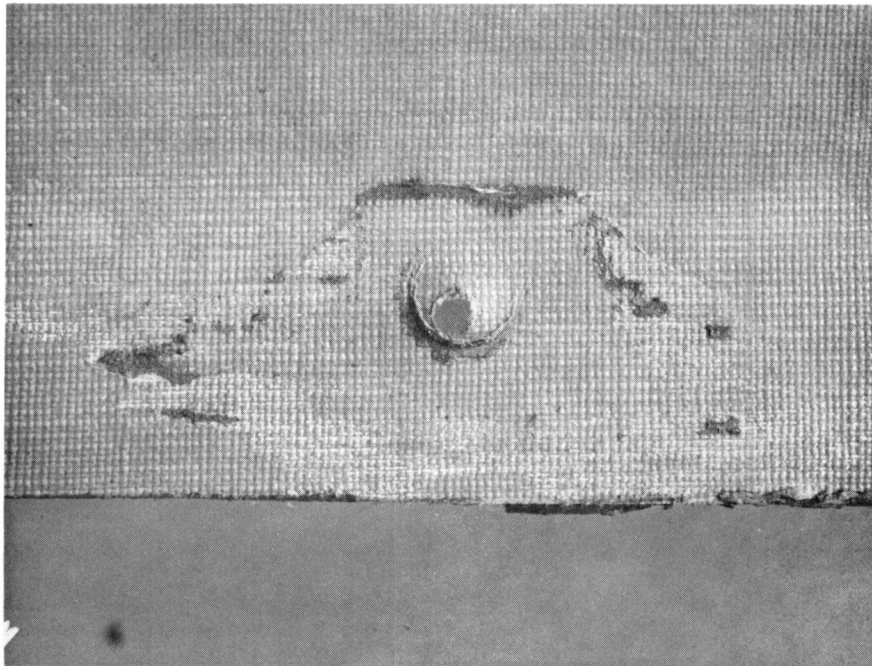
5. Slight fraying was observed on all the fastener holes. All holes on the lower edges had slight elongation and noticeable mark-off of the washers, with a convex deformation of the laminate around the holes. (Figure 13). Several holes on the other edges were slightly elongated. Two holes on the top edge at the forward end were badly frayed and elongated to a 0.6 cm ($\frac{1}{4}$ in.) maximum dimension. (Figure 14).

Figure 13. - Eastern left-hand wing-body fairing - fastener hole on lower edge with mark-off.

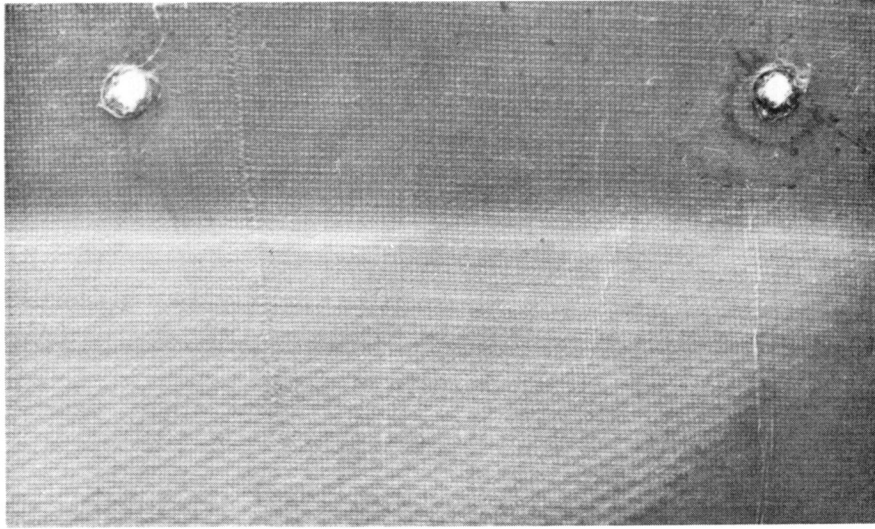
Figure 14. - Eastern left-hand wing-body fairing - frayed and elongated holes on top edge.

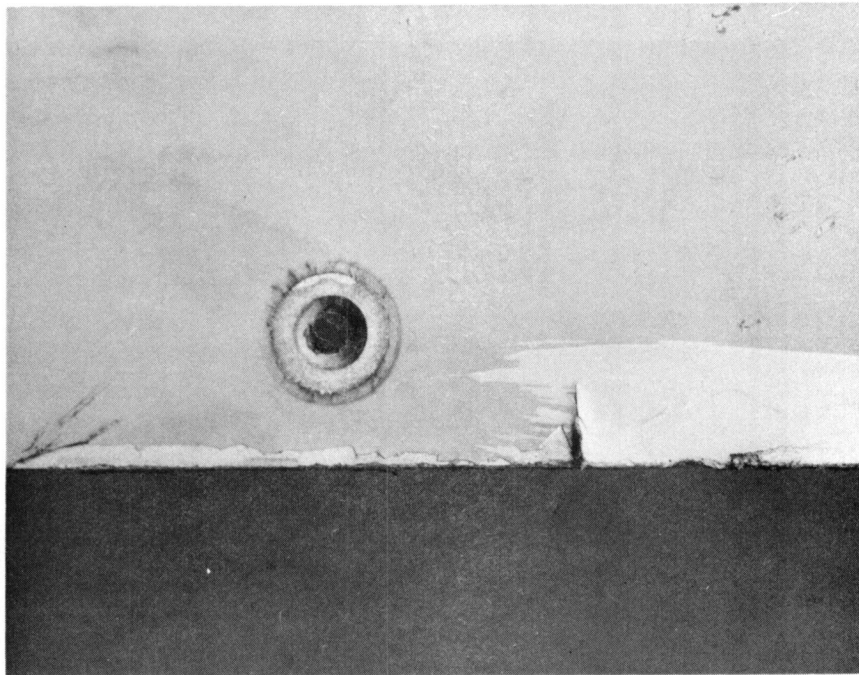
1. Several exterior surface cracks observed in previous inspections had not propagated or changed in appearance:
 - A 1.3 cm ($\frac{1}{2}$ in.) crack in the forward edge between the fifth and sixth holes from the top. (Figure 15).

Figure 15. - Eastern right-hand wing-body fairing - crack in forward edge.

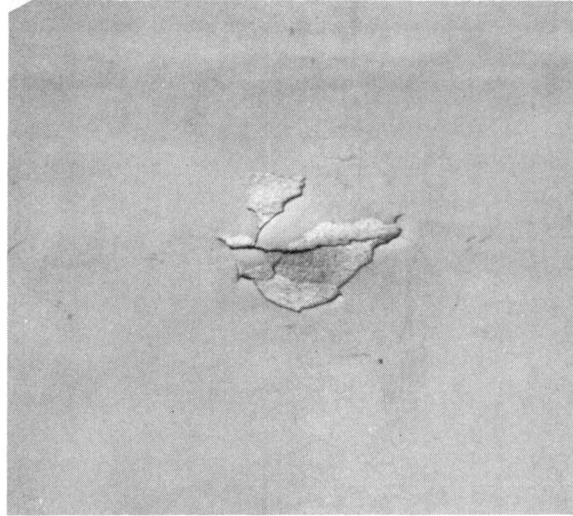
- A 0.3 cm ($\frac{1}{8}$ in.) ding in the lower center area.
 - A 0.3 cm ($\frac{1}{8}$ in.) crack in the aft center area.
 - A 0.8 cm ($\frac{5}{16}$ in.) crack in the lower forward area. (Figure 16).

Figure 16. - Eastern right-hand wing-body fairing -
0.8 cm (5/16 in.) crack on exterior surface.

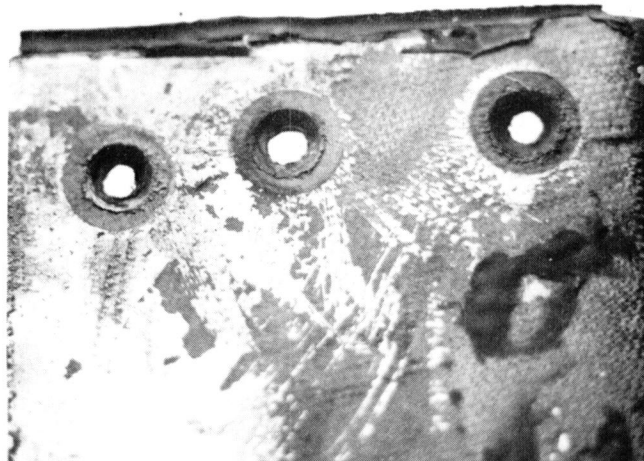
Figure 17. - Eastern left-hand underwing fillet - frayed
and elongated fastener holes from exterior.

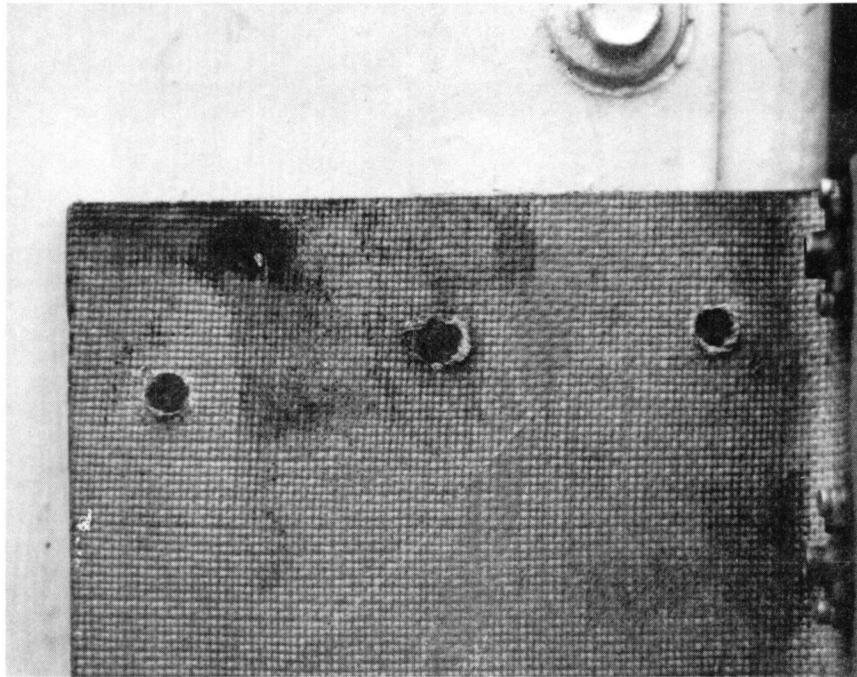
Figure 18. - Eastern right-hand underwing fillet - frayed and elongated holes from inner surface.

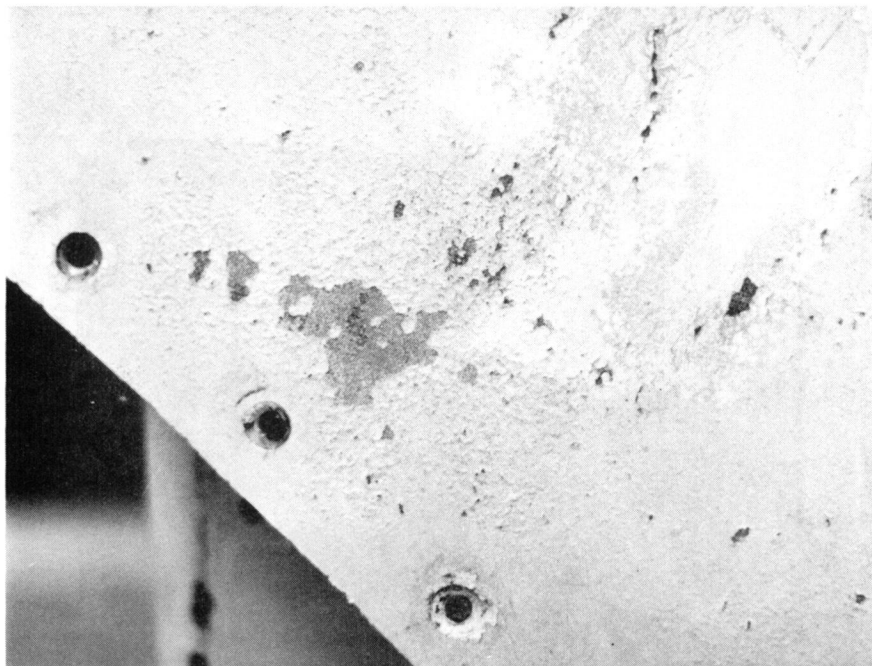
1. No damage or defects were noted on the inner surface, but there was loss of paint and flame spray in two exterior surface areas with the Kevlar-49 surface exposed to ultraviolet. (Figure 19). These areas were relatively small, with the largest 15 cm (6 in.) diameter in the upper aft corner area. There was a slight associated abrasion in the center of this area with a few exposed Kevlar-49 fibers. This part had been inspected by Eastern Maintenance in 1977 and a puncture in this area covered by tape was observed at that time. This abrasion appears to be the same as the previously reported puncture, but there was no longer any tape, and any full skin penetration had been filled in some manner and repainted. In 1978, the

Figure 19. - Eastern left-hand aft engine fairing - paint and flame spray loss with exposed Kevlar-49 laminate.

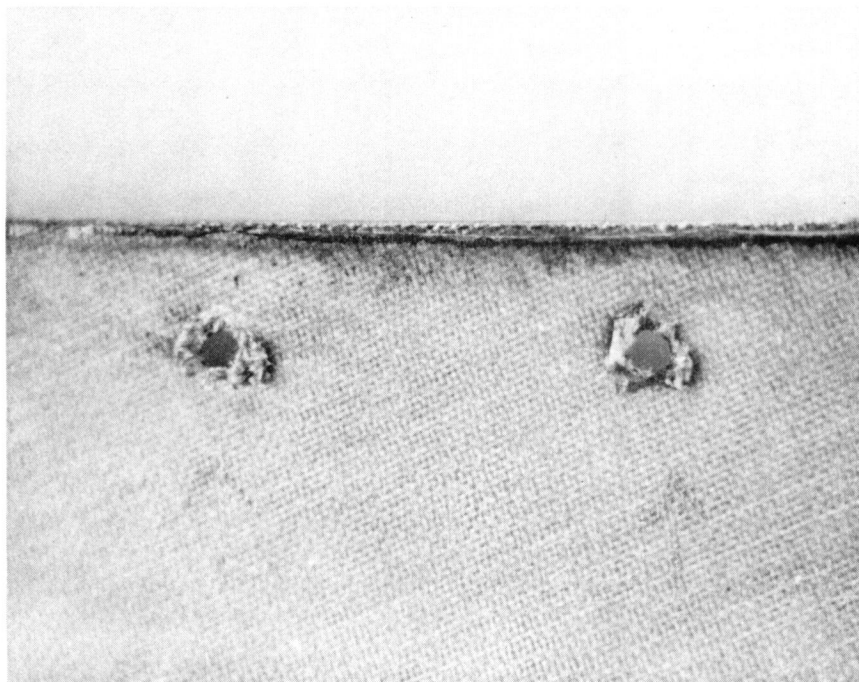
2. Fraying was observed on all fastener holes. This fraying was more severe than on the wing-body fairing and under-wing fillet panels. (Figure 20). The intercostal holes were less frayed than the holes in the solid laminate edge member. Slight elongation was observed on about 10% of the holes.

Figure 20. - Eastern left-hand aft engine fairing - fastener holes with severe fraying.

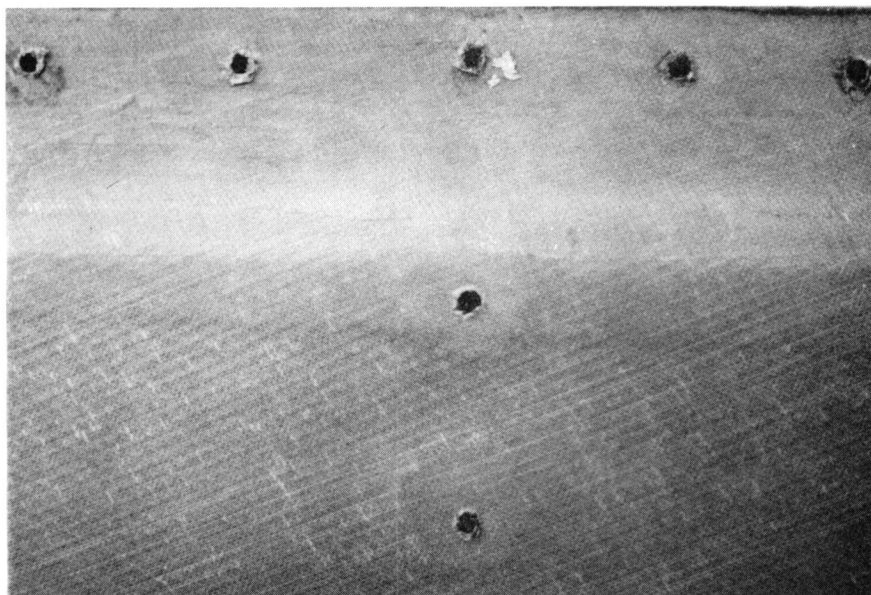
Figure 21. - Eastern right-hand aft engine fairing - fastener holes with moderate fraying.

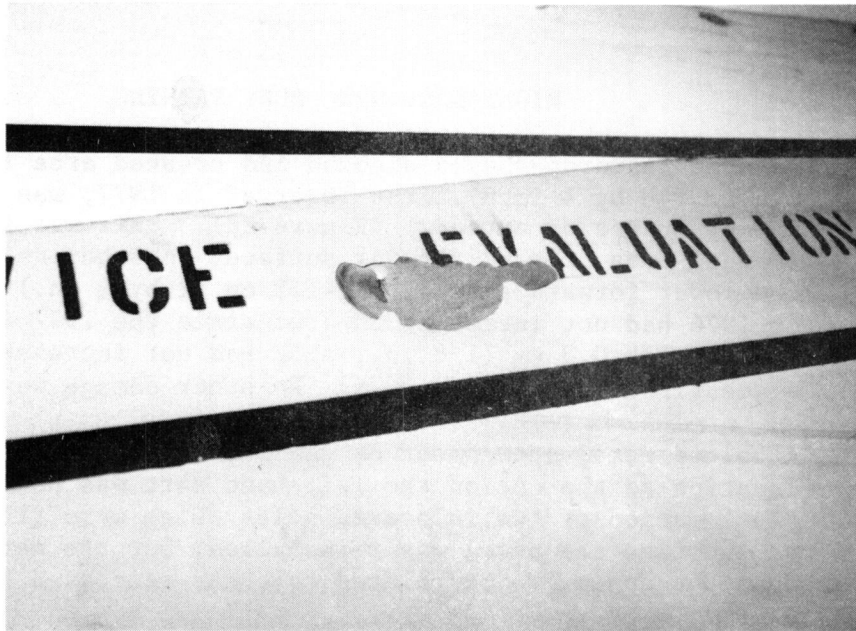
1. Two exterior surface defects observed in previous inspections had not increased in area. These were a deep gouge 1.3 cm ($\frac{1}{2}$ in.) length in the upper forward area (Figure 22) with a disbond area extending forward of the gouge in a 1.3 cm ($\frac{1}{2}$ in.) radius arc; and a small 0.3 cm ($\frac{1}{8}$ in.) crack in the upper aft area, which had been painted over in the previous inspection. The crack was first observed in 1977, and the gouge was first observed in 1978.

Figure 22. - TWA left-hand wing-body fairing - 1.3 cm ($\frac{1}{2}$ in) crack on exterior surface.

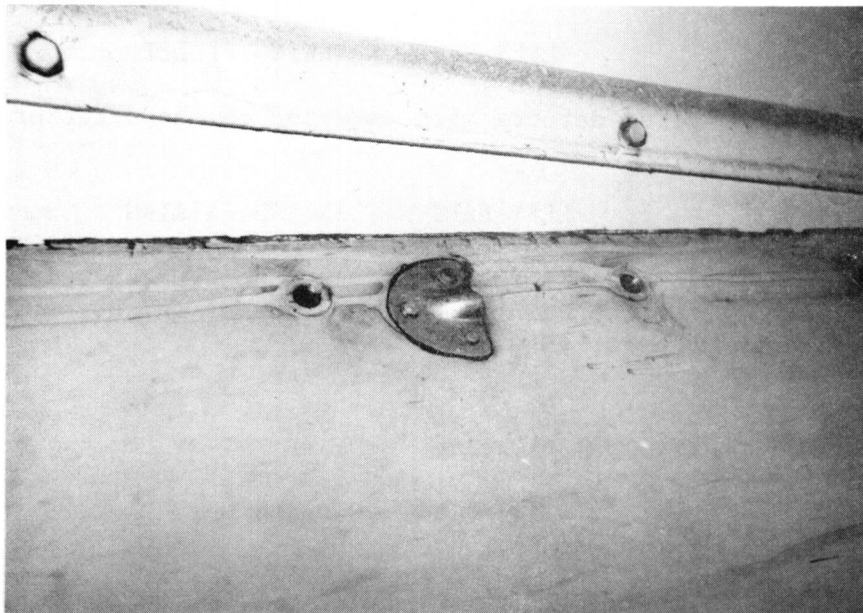
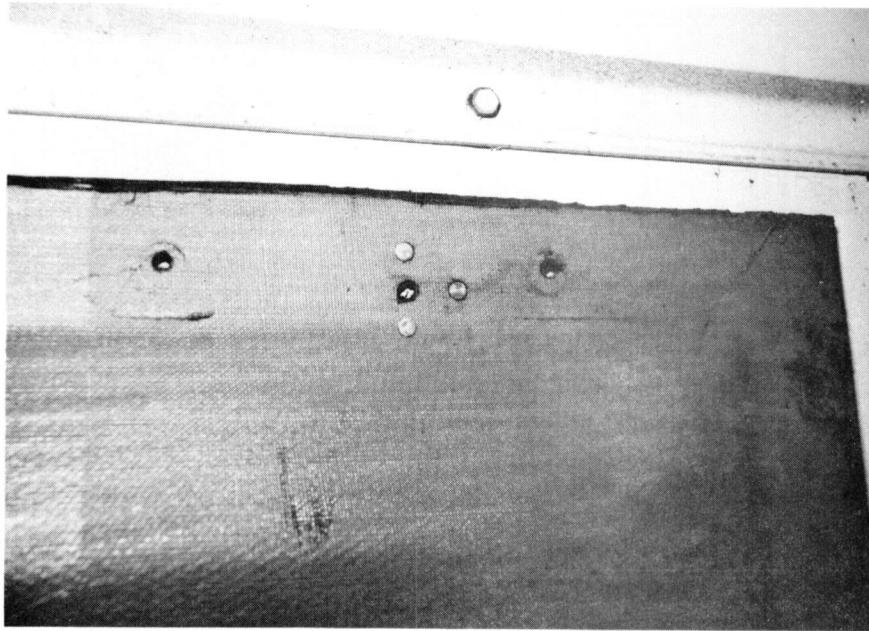
4. A bolted metal attachment covering a filled fastener hole was observed on the lower edge between the two aft holes. (Figures 23 and 24). When the panels were reinstalled, there was no record of hole relocation on the left-hand fairing

Figure 23. - TWA left-hand wing-body fairing - metal attachment from exterior.

Figure 24. - TWA left-hand wing-body fairing - metal attachment from interior.

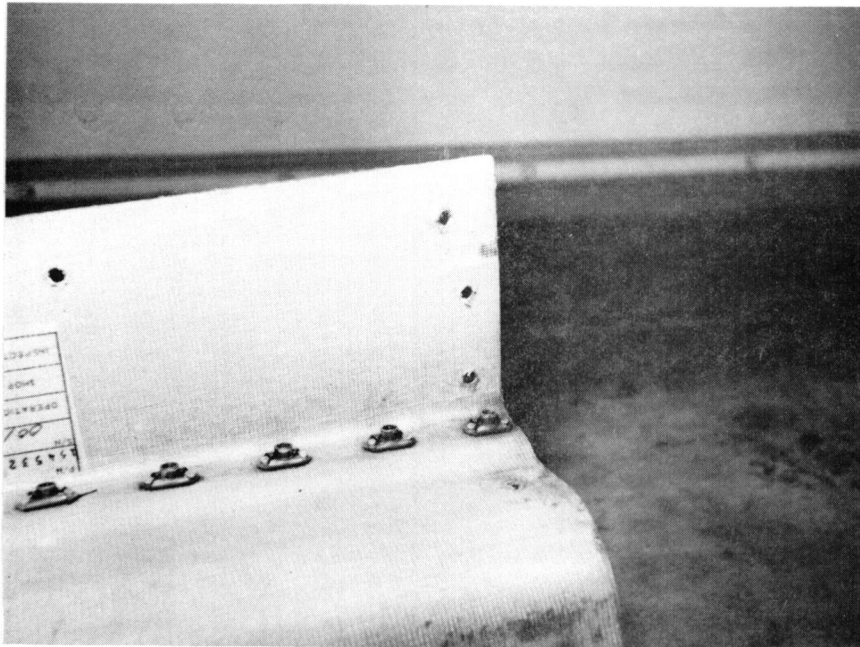
Figure 25. - TWA right-hand underwing fillet - fastener holes with frayed condition.

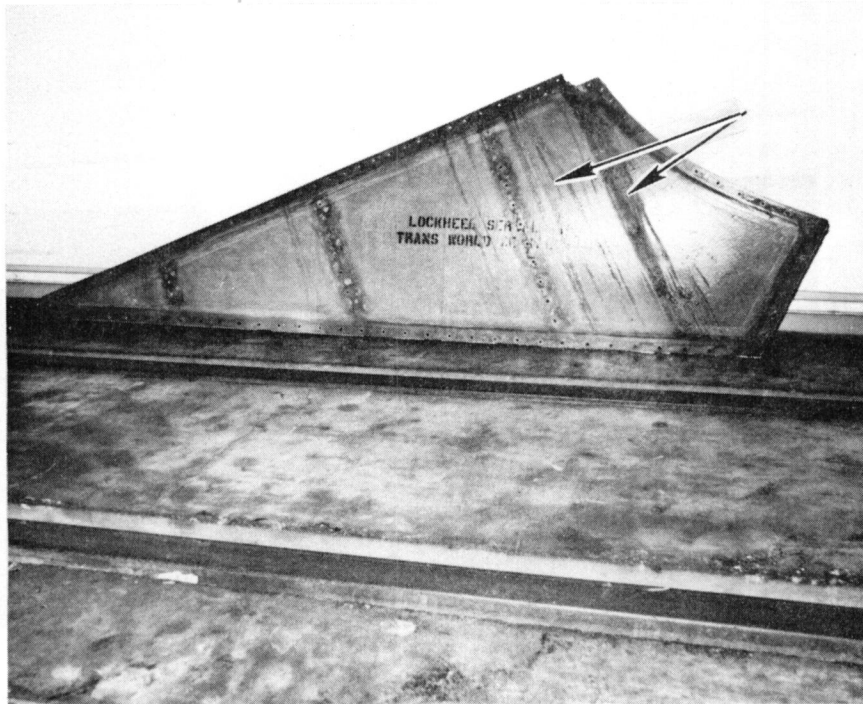
1. There was no damage to either surface. Loss of paint and flame spray had left some exposed Kevlar-49 surface. The vapor barrier coating, which had been applied to the inner surface during reinstallation to replace the Tedlar film, had been chemically attacked in several areas, probably by Skydrol. (Figure 26).

Figure 26. - TWA right-hand aft engine fairing - inner surface with vapor barrier coating showing chemical attack.

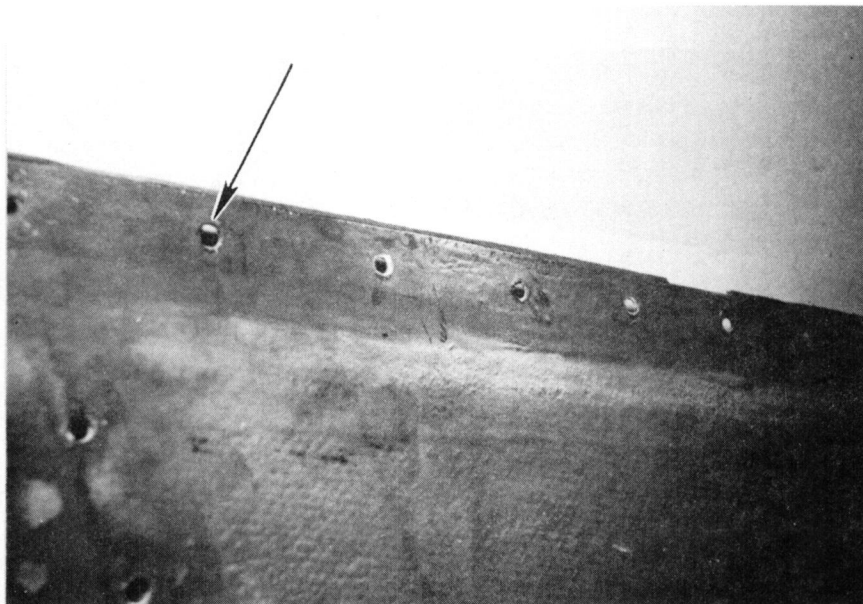
Figure 27. - TWA right-hand aft engine fairing - showing unfrayed fastener holes and an elongated hole.

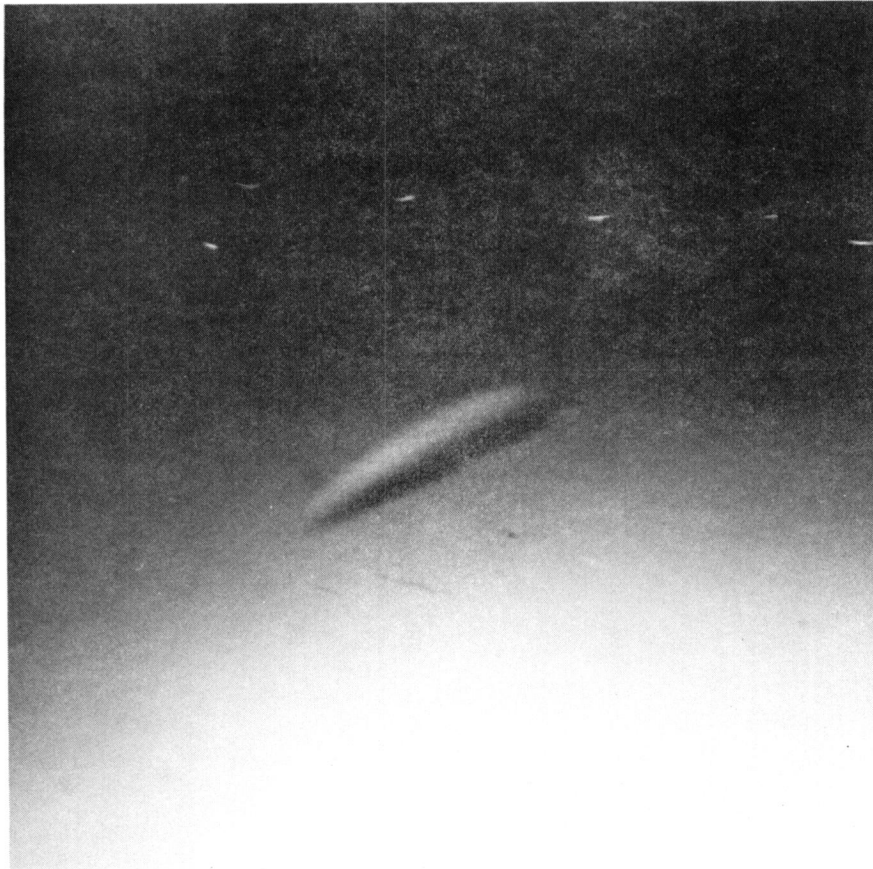
A different type of damage was initially observed in 1977 on the right-hand TWA wing-body fairing. This was a large teardrop shaped disbond area 11.4 by 2.5 cm (4.5 by 1 inch) in area with an associated deep concave depression indicative of core crushing. The paint and flame spray were intact with no cracks or crazing. This disbond has not increased in area or depth since the 1977 inspection. A similar but smaller disbonded and depressed area was initially observed in 1976, and has not grown since the 1977 inspection. These occurrences, which are unique to this particular fairing, are probably related to a repair made when the part was reinstalled on Ship 1111 (ref.3). This repair was not documented, but apparently consisted of replacement of a damaged core area, extending partially through the core thickness, with a microballoon-filled potting compound. This is not therefore a Kevlar-49-related problem, but as it is a highly visible condition it will be monitored in future inspections.

1. A large teardrop-shaped disbond and crushed area 11.4 by 2.5 cm (4½ by 1 inch) first observed in 1977, was unchanged in appearance or extent. (Figure 28). This was in the lower forward area of the exterior surface. Another delamination in the lower forward area 5.1 by 1.3 cm (2 by ½ in.) first observed in 1976 had not increased in area since the 1977 inspection. A small crack 0.3 cm (1/8 in.) also had not increased in length since first observed in 1976. No other damage was noted.

Figure 28. - TWA right-hand wing-body fairing -
disbonded and crushed area on exterior.
